**Heritage Impact Assessment: portion 5 Dornoch Farm,  
Balgowan District**

**Prepared for: Mark Logan, Stonegrove Estates (Pty) Ltd, Balgowan**

# **Heritage Impact Assessment: portion 5 Dornoch Farm, Balgowan District**

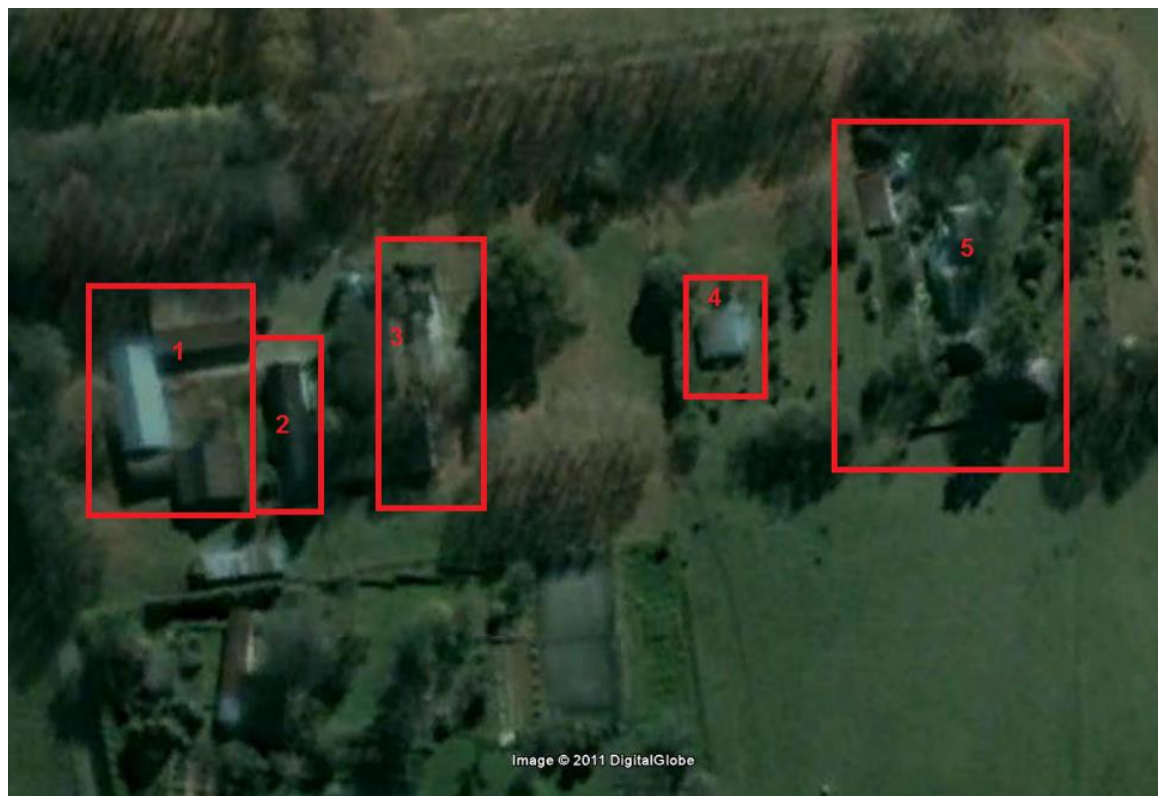
**Fig 1: 'Google' earth photograph showing complex of buildings**

**1: Barn complex and stables**

**2: 'Old barn'**

**3: Servants quarters**

**4: Shed**

**5: Thatched house**

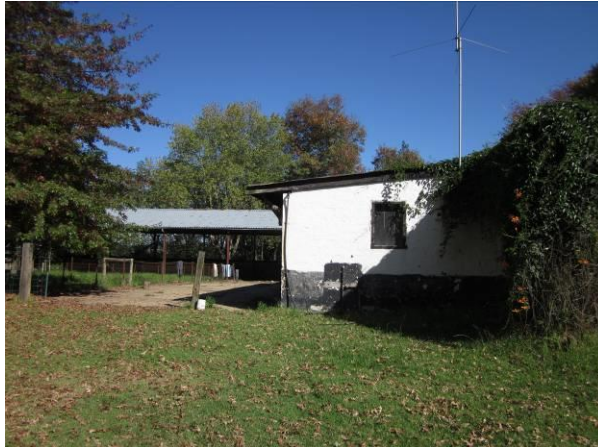
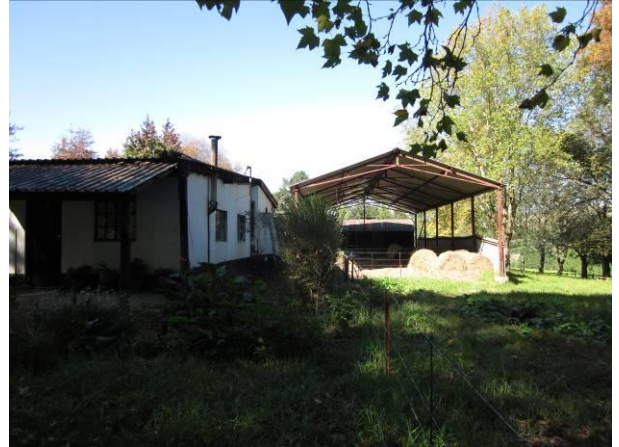
This is a collection of mixed material buildings: a long open shed lies parallel to the 'Old Barn' and this is seen to the left in Figure 2 below, as well as from the end on in Figure 3. It is a portal frame structure of recent construction, and has little merit. Close to this is a mixed construction building housing stables, a garage workshop space and a cottage. This is built of concrete block, amongst other materials, and has an IBR roof and standard steel window sections. The walls are bagged and plastered and there is no evidence of any forms of bonding apart from stretcher. This is seen to the right in Figure 2 and the left in Figure 3. Figure 4 shows the length from the driveway approach. It has not been maintained and needs some work. To the south, facing the rough yard space, are a few large loose-boxes and feed rooms. Figures 6 and 7 show older sheds in the yard.

*Fig 2 (left) and Fig 3 (right): Showing long open shed and mixed use building*

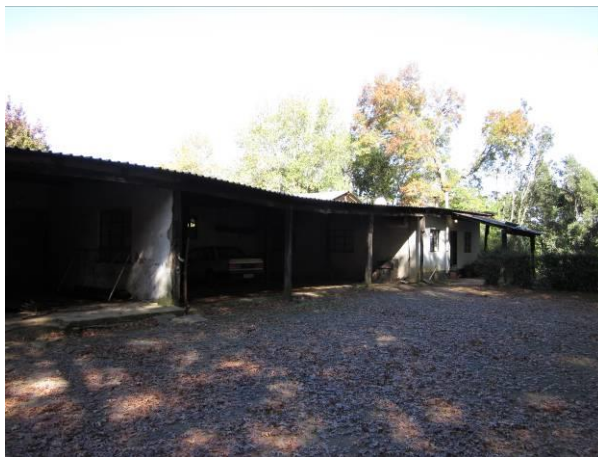
*Fig 4: Length of mixed use building*

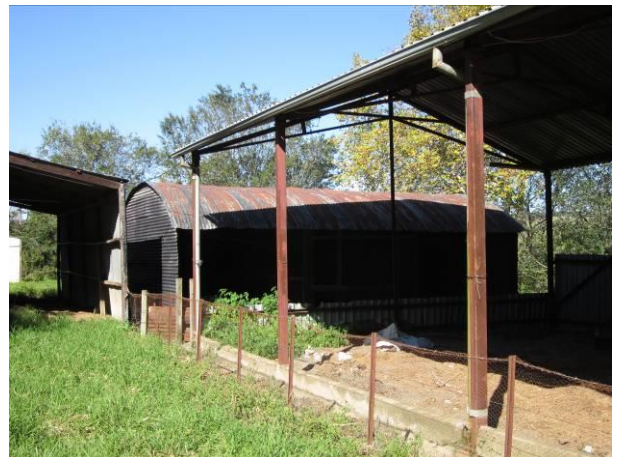
*Fig 5: Cranked corrugated iron shed at rear*

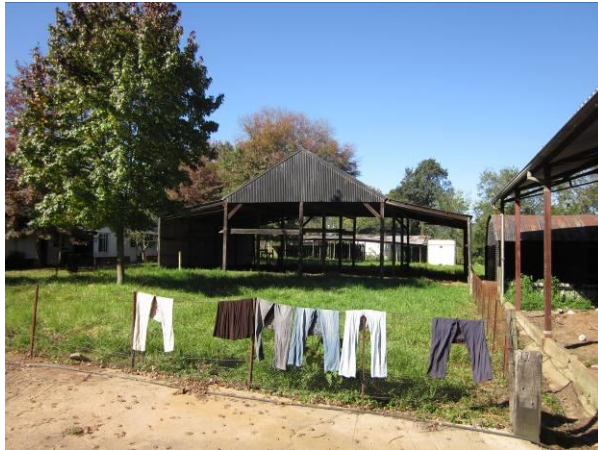
The structures in this complex are utilitarian, ill-maintained, and would be difficult to reuse. It is doubted that any of these is over the age of 60 years, although the shed in Figures 6 and 7 are probably reasonably close. There is little cohesion in material, style and scale, and it is evident that these structures have been incrementally planned, as one would expect in an agricultural environment.

**Fig 6: Hipped, corrugated iron shed at rear**

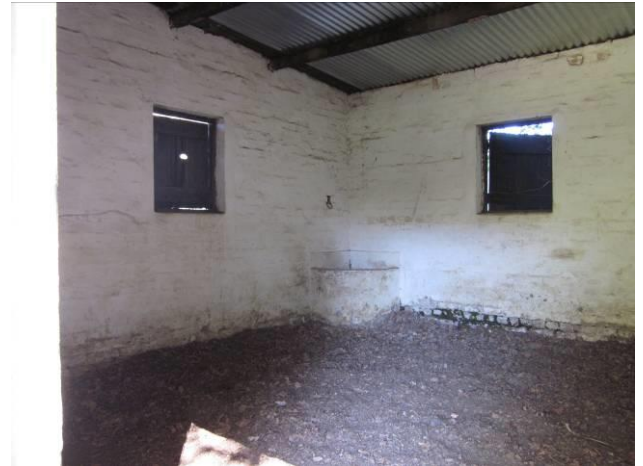
**Fig 7: interior of loose-box**

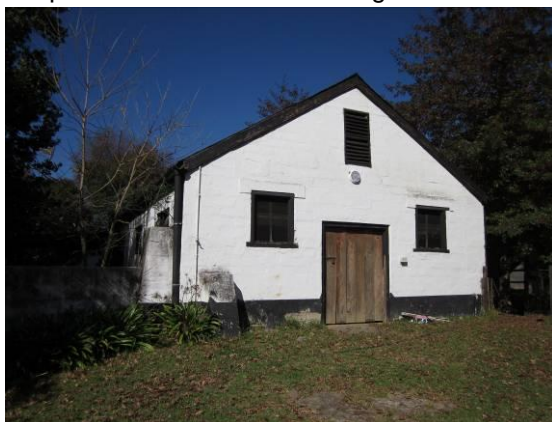
This structure is perhaps the most enigmatic. It is a long building of masonry construction, under a pitched corrugated iron roof. It ends right on the southern boundary of the farm. The short elevations have louvred timber ventilators to the roof space. The long elevation has been much altered, with an anachronistic bay window (see Fig ) added to the southern end. Double meranti cottage pane doors and flanking windows sit close to a painted timber double door. Internally, the space has been fragmented into habitable rooms, and the floor tiled.

**Fig 8: Old Barn, north end**

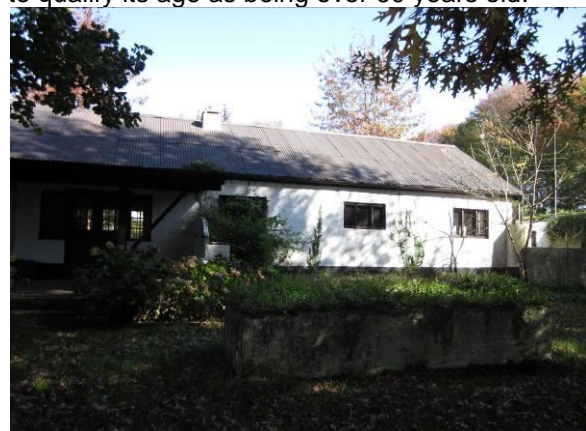
**Fig 9: Long elevation to east**

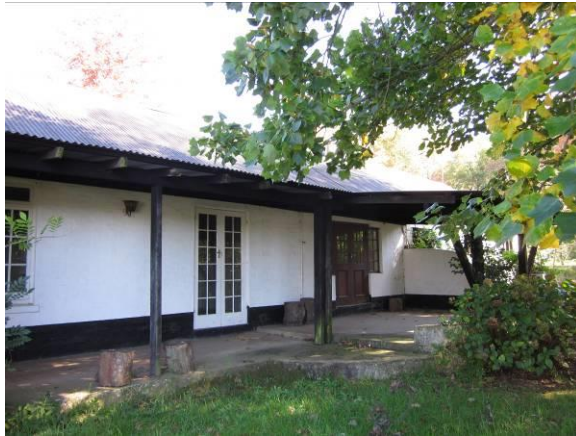
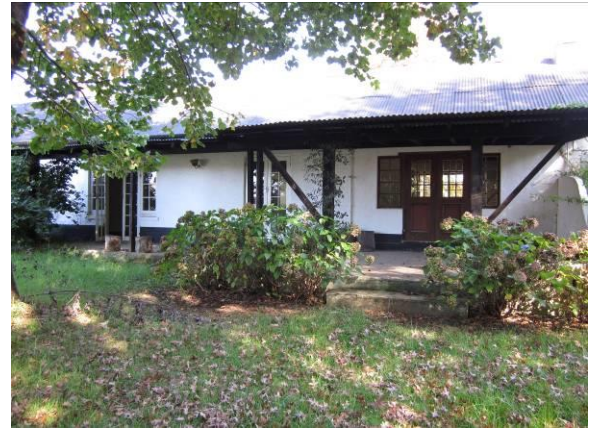
**Fig 10 and 11: Old Barn veranda to east showing varying door types**

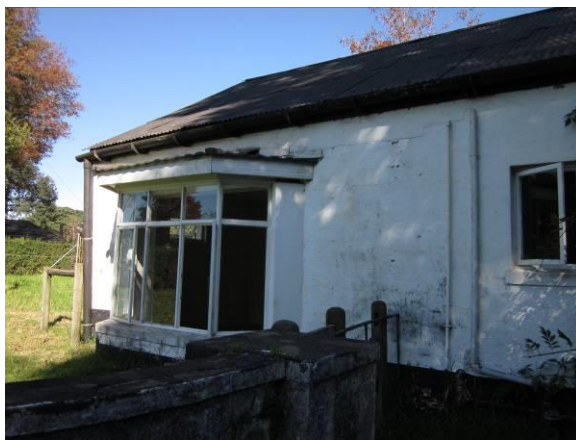
**Fig 12: New bay window added to Old Barn**

It is not confirmed that this building is older than 60 years, given that its components are traditional and typical of utilitarian buildings of this nature. Its original fabric has been much altered, as well as the internal spaces, leaving little integrity where the envelope has been manipulated using a series of unrelated components which do not work together. Were this structure a functioning barn, as its architectural language suggests, then this has been materially altered, leaving little of any merit. In all this building has little to merit its retention.

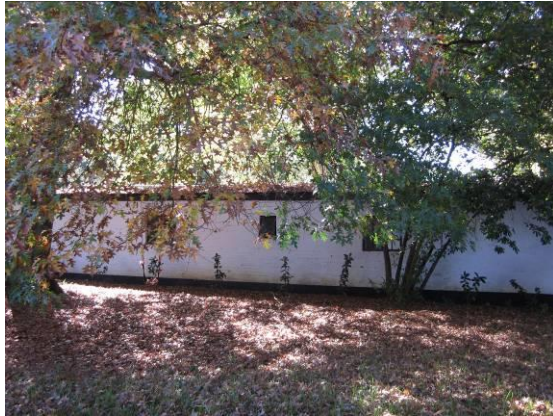
This is another long low building which sits adjacent to the Old Barn. It is a series of compartments which housed servants in the past, again utilitarian in nature and consisting of bagged and painted stretcher bond brickwork and standard steel windows under a corrugated sheeting roof.

**Fig 13: Servants quarters seen from Old Barn**

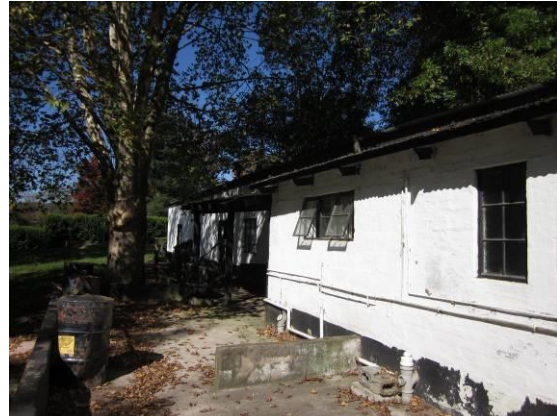
**Fig 14: Servants quarters- east elevation**

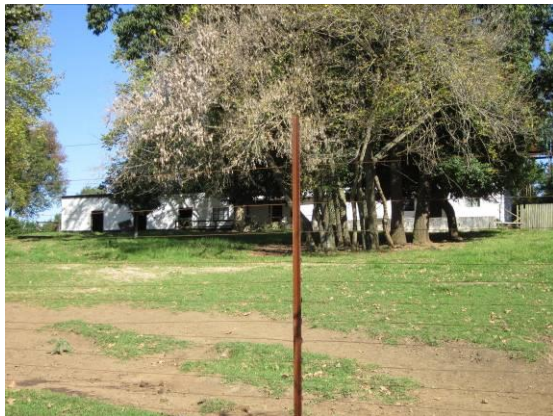
**Fig 15: Servants quarters from thatched house**

This is a purely utilitarian building of uncertain age. As it stands, it has minimal aesthetic or architectural merit.

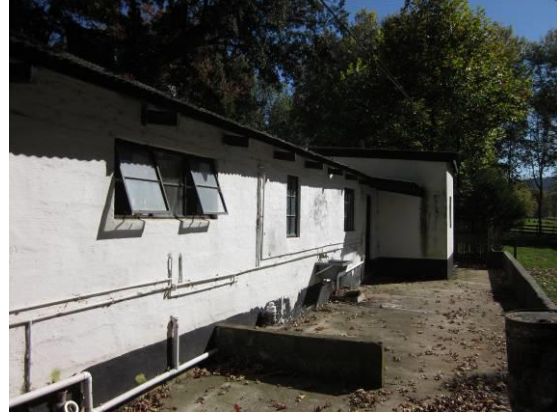
**Fig 16: Servants quarters-east elevation**

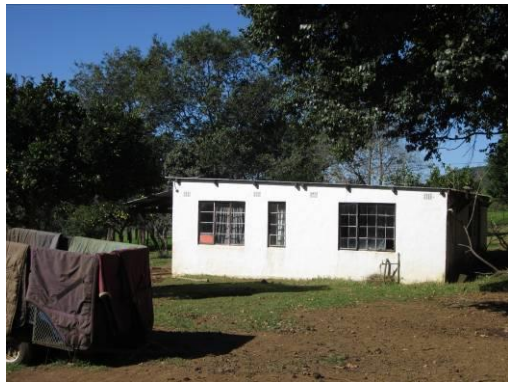
This building is of recent construction, with a low mono-pitch corrugated sheeting roof on masonry construction with large steel section openings. There is little merit in its retention.

**Fig 17: The shed from the thatched house**

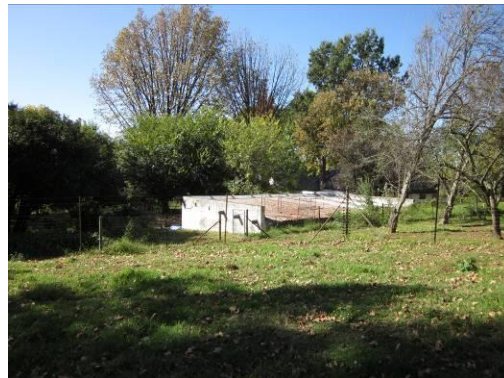
**Fig 18: The shed from the servants quarters**

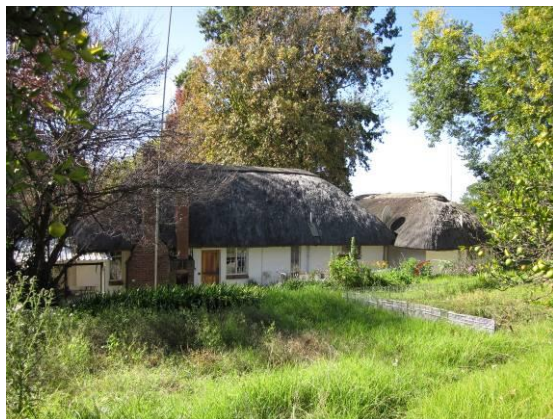
**Fig 19: Thatched house viewed from the shed**

This building was reconstructed after a fire in the late 1960s. It consists of a number of structures including a garage and a cottage. It is thatch on masonry construction with a number of unstable brick chimneys. It does not fall within the protection of the Heritage Act, and has little merit to promote it.

*In the opinion of this author, demolition of the structures on Dornoch Farm is recommended.*
